**Conditions Assessment and  
Treatment Recommendations  
for the  
Masonry Components of the Johnson Gates  
Boston**

**December 6, 2013**

**Conditions Assessment and  
Treatment Recommendations  
for the  
Masonry Components of the Johnson Gates**

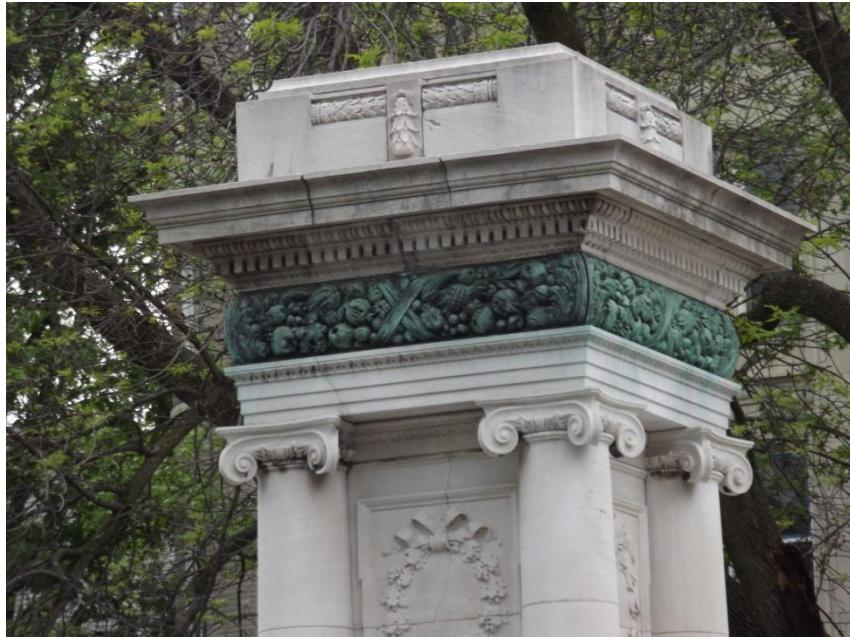
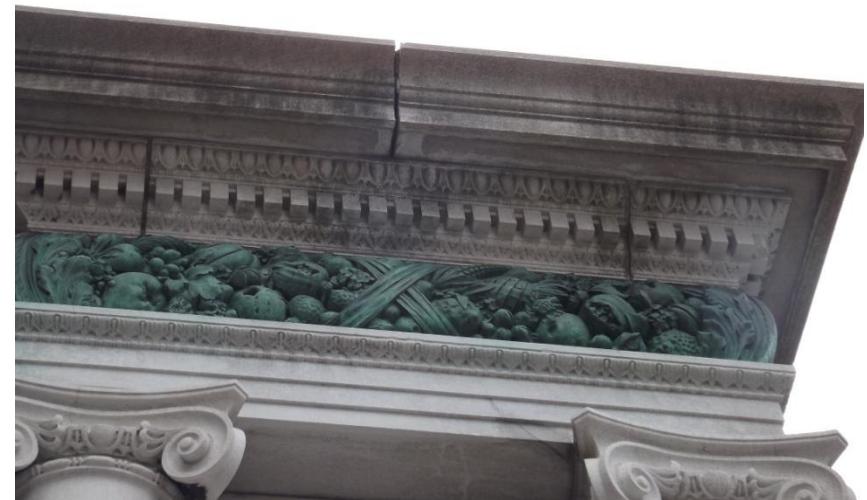
The upper section of the piers consists of an enormous cap stone set on top of the cornice which consists of small units. The entablature stone under the bronze work is a single unit of stone.

The mortar joints in the two courses of the cornice are completely open. The entablature stone on each pier is cracked in several locations but the cracks are not structural.

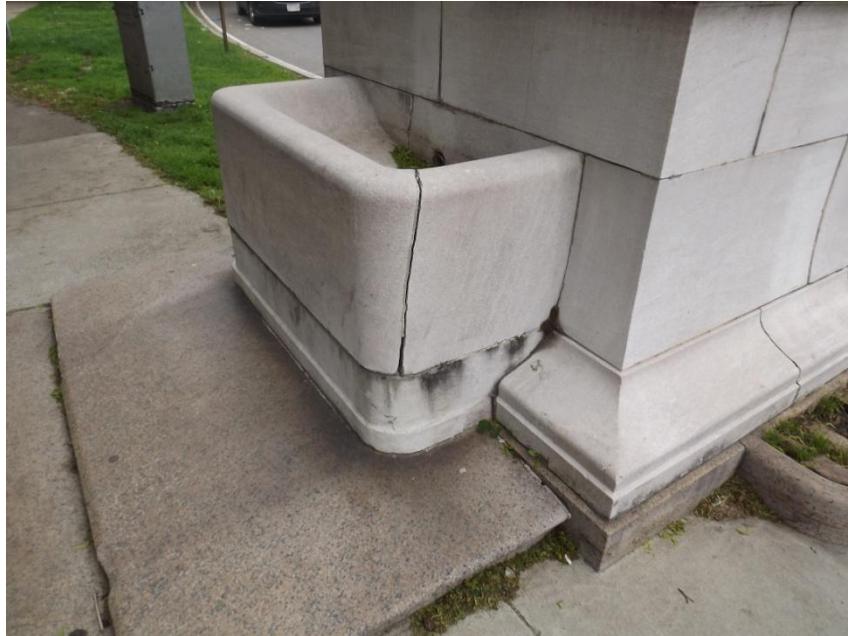
The units that make up the original fountain portion of the piers - the projecting basins and adjacent units - are severely cracked, in multiple locations, due to the likely expansion of ferrous pipes and plumbing fixtures. The basin on the south pier is cracked diagonally from west to east. Water that enters the basin flows through the crack and comes out at the mortar joints between the basin and the unit below. The outboard fragment of the south pier basin is displaced from either the expansion of ice or the plumbing fixtures.

**Crack at fountain basin on the south pier.**

1. Remove cracked portion of fountain basin and then reattach to section that remains in the wall using epoxy and stainless steel anchors. Grout crack with tinted repair mortar.

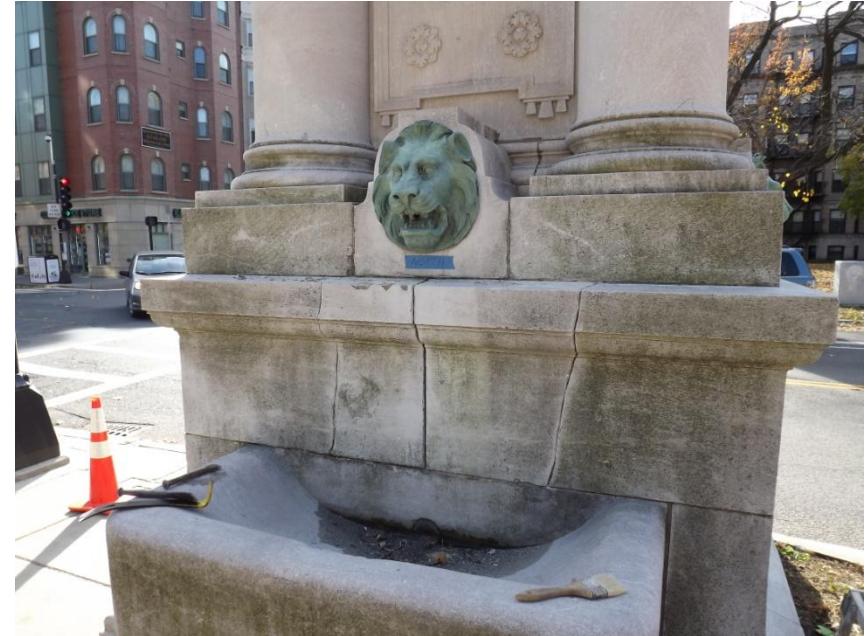
**Cracks above fountain basin on the north pier.**

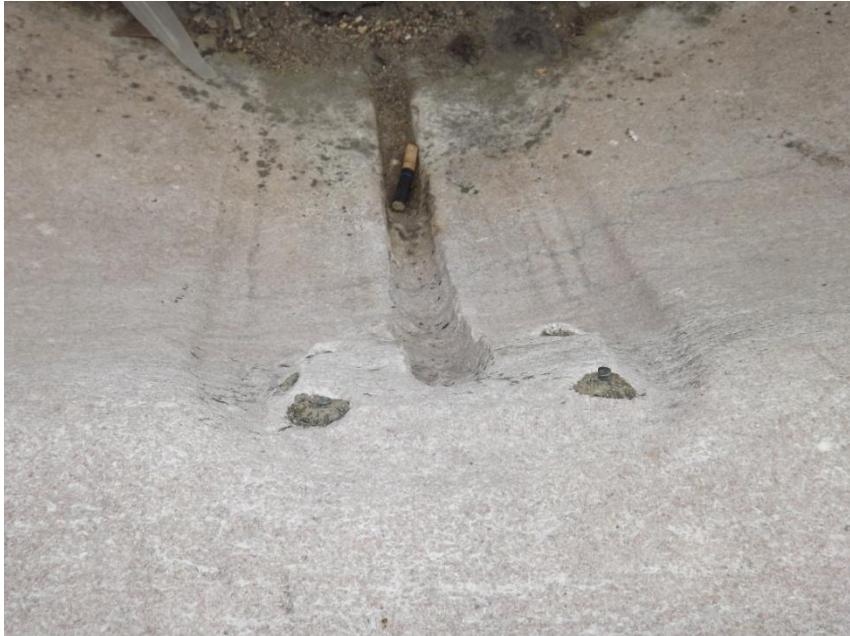
**The original bronze fixtures that supplied water to the basins have been removed and the holes are plugged with mortar.**

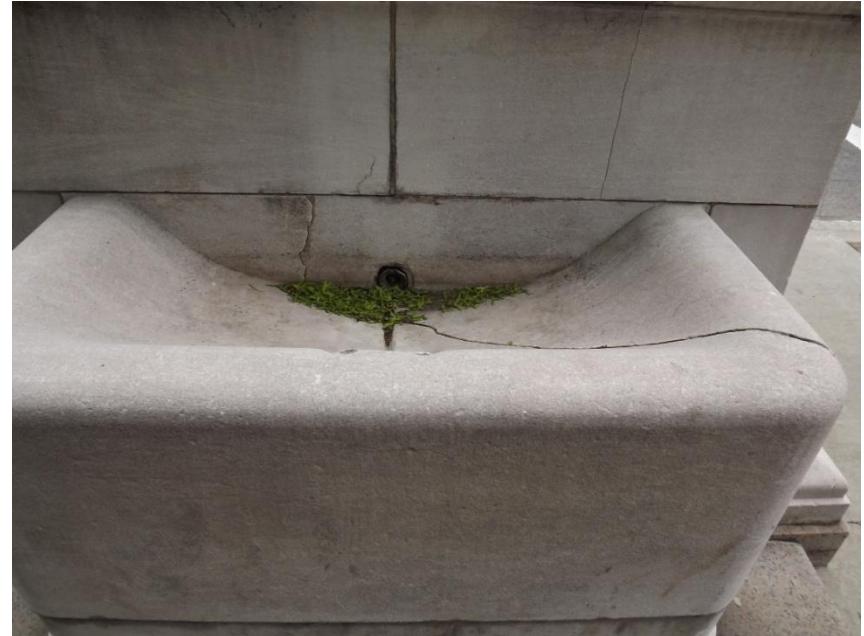
**The basin on the south pier is cracked. Water has been entering the drain and either flowing into the masonry core and freezing and/or corroding and expanding the plumbing pipes.**

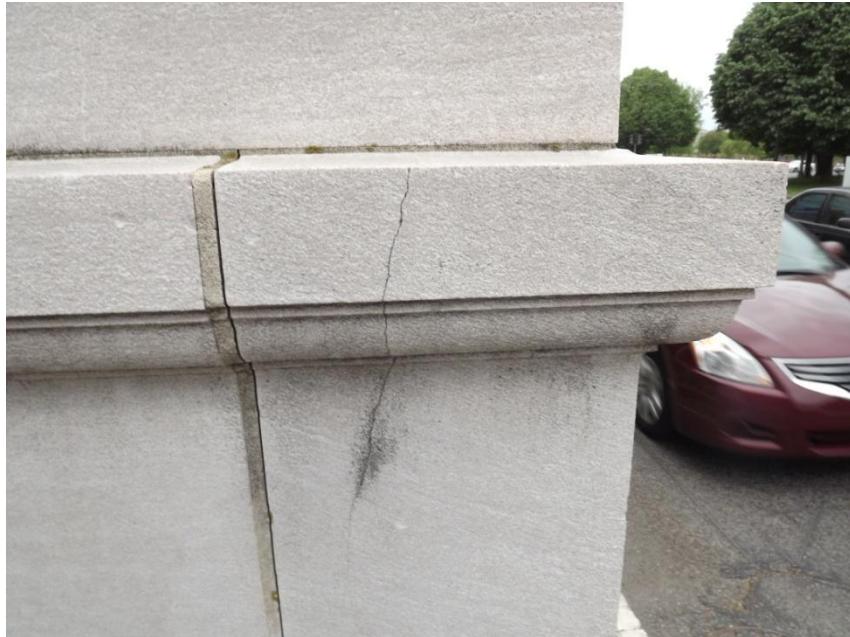
**The lower sections of the piers have many cracked and displaced units. The cracking and displacement is most likely the result of water freezing and expanding between the core and the units.**

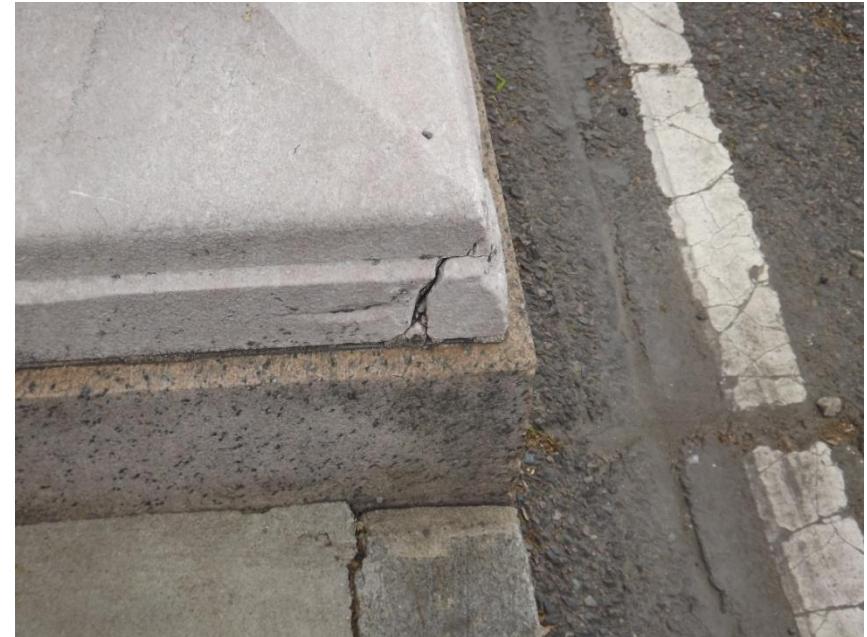
**The granite bases and lower marble units have cracks from impact with vehicles.**

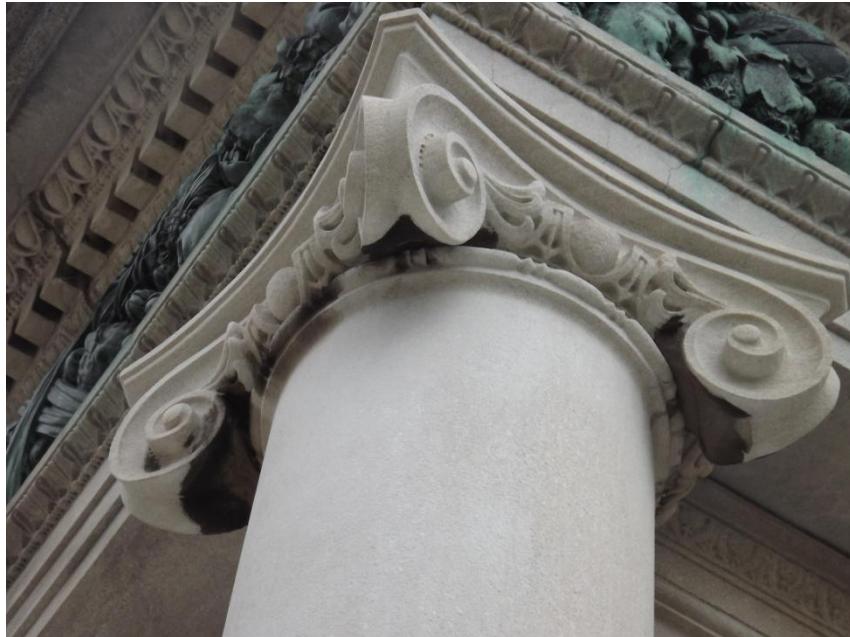
**The undersides of projecting elements such as the volutes have heavy black sulfation stains. These stains can be removed with using a continuous spray of water.**

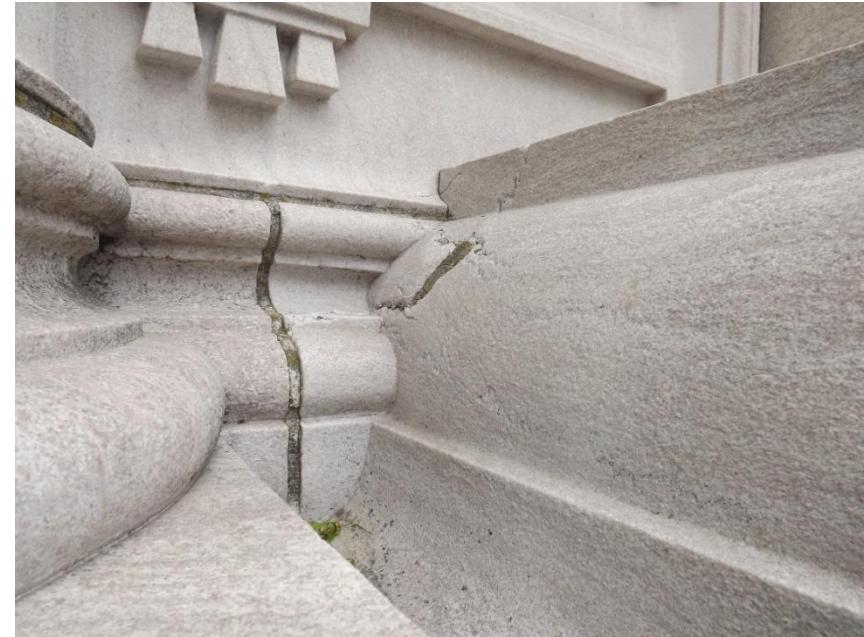
**An earlier crack repair is visible on the right. This crack is the result of an inherent weakness in the stone. These old repairs should be removed and replaced with a repair that is tinted to match the stone.**

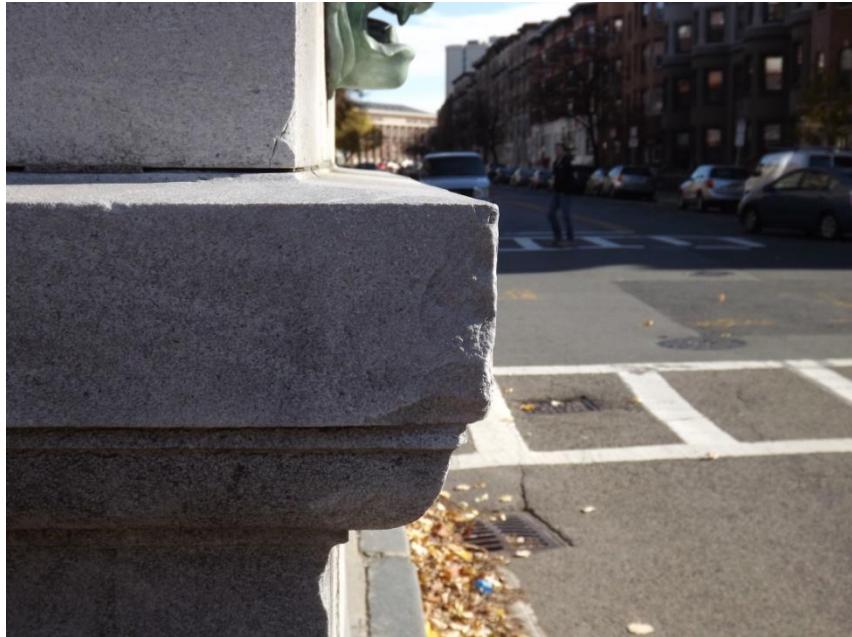
**Corner units have been spalled from vehicle impact.**

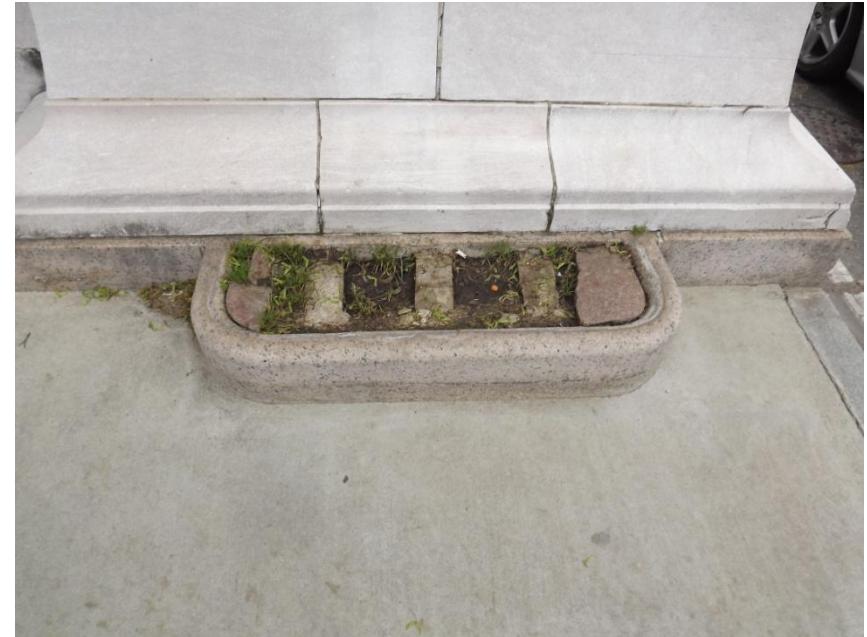
**The granite cover is missing at the south pier.**

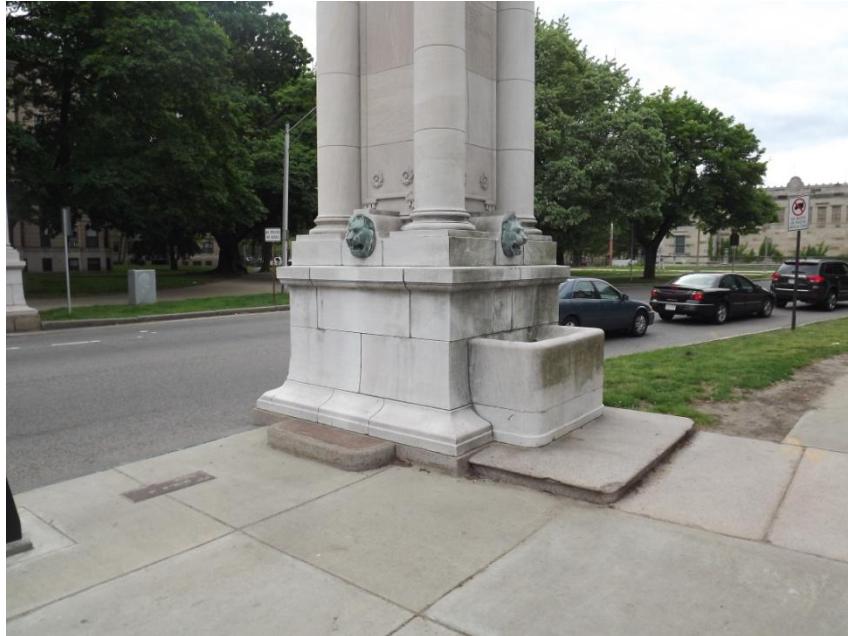
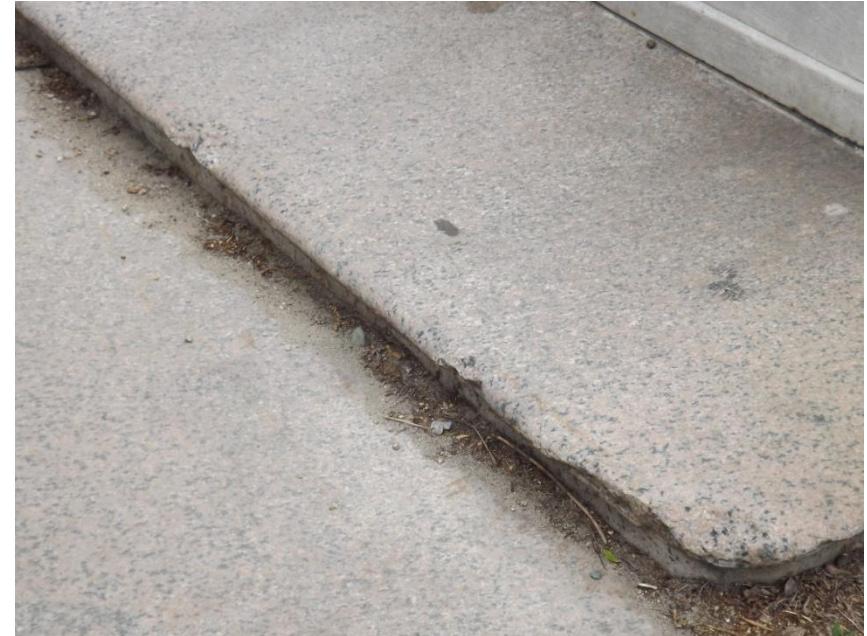
**The Milford Pink Granite bases have large spalls (losses) caused by impact with vehicles or construction equipment.**

These areas of loss have been patched in the past but the patches did not hold. The most durable repair would be to cut the areas of loss square and then insert a matching piers of granite. This type of repair is called a “dutchman”.

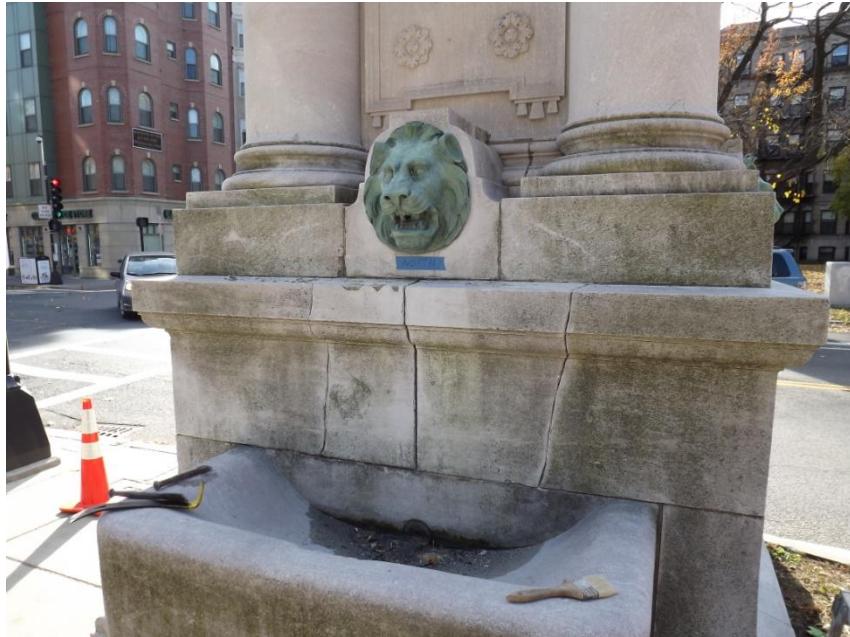
Mortar was removed from around cracked unit above basin on the north pier in an attempt to remove the smaller section of stone and access the plumbing for the fountain.

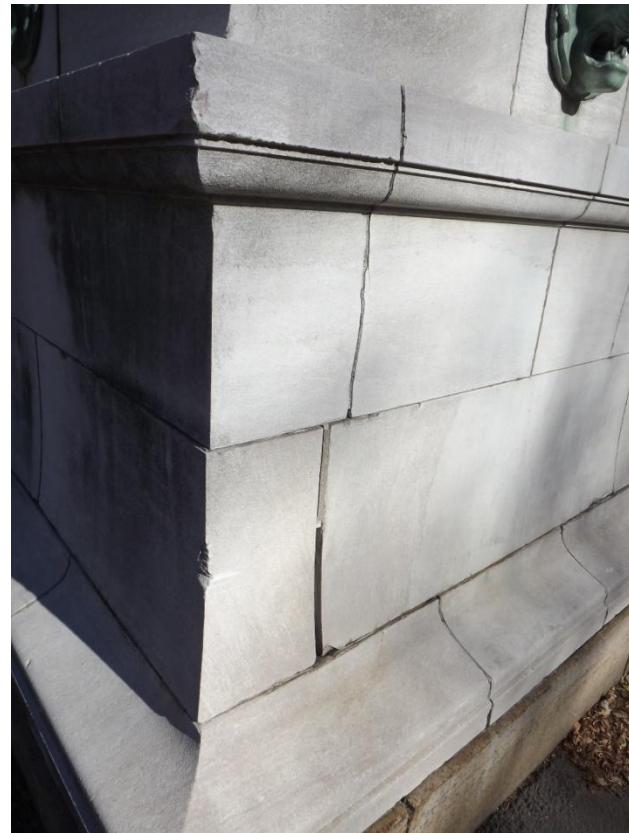
Note wide vertical joints where stone cladding at the base of the south pier has shifted and cracked. Holes were drilled through the wide mortar joints to reach the core within the pier.

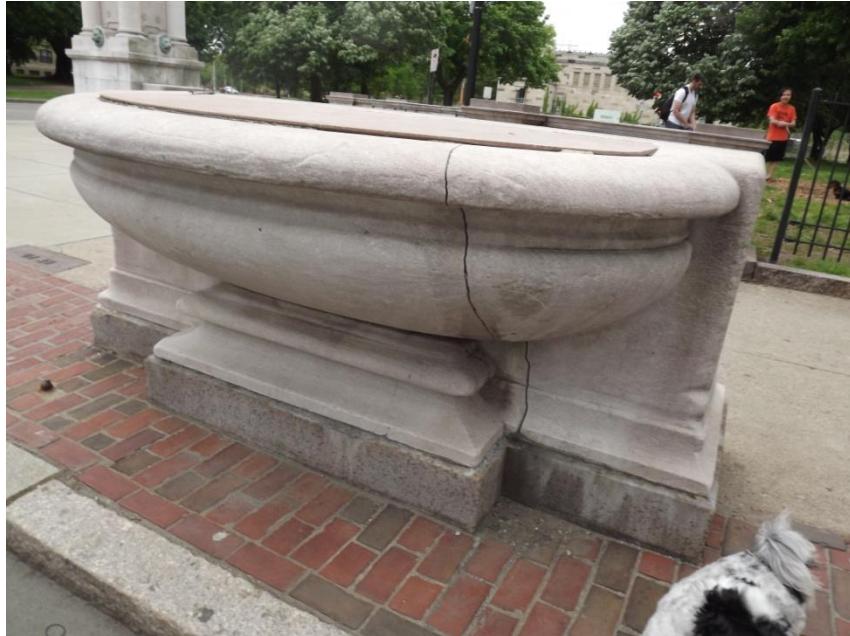
- The cause of the cracking of the north trough appears to be the expansion of ice forming inside the trough in the winter. Water flows freely into the trough through the gaps around the cover. The trough is filled with sand and the volumetric expansion of freezing water in the trough is compounded by the presence of the sand in the trough.

The crack in the north trough does not extend to the granite base - an indication that the cause of the fracturing of the trough is not related to the settlement of the base. The most likely cause of the cracking of the trough is the expansive force of ice forming in the trough when the sand is saturated.

**Crack at north end of trough extends through to the other side, effectively splitting the trough into two pieces.**

3. Clean out large crack at the north end of the trough and apply a slow setting epoxy to the mating surfaces. Cinch the fragment back into place. Install stainless steel cramp anchors across the fracture on the inside of the trough.
4. Install stainless steel supports for cover and reset cover on plastic shims. Install a tinted flexible sealant (caulk) between the lid and the sides of the trough.
5. Do not correct tilt of base.

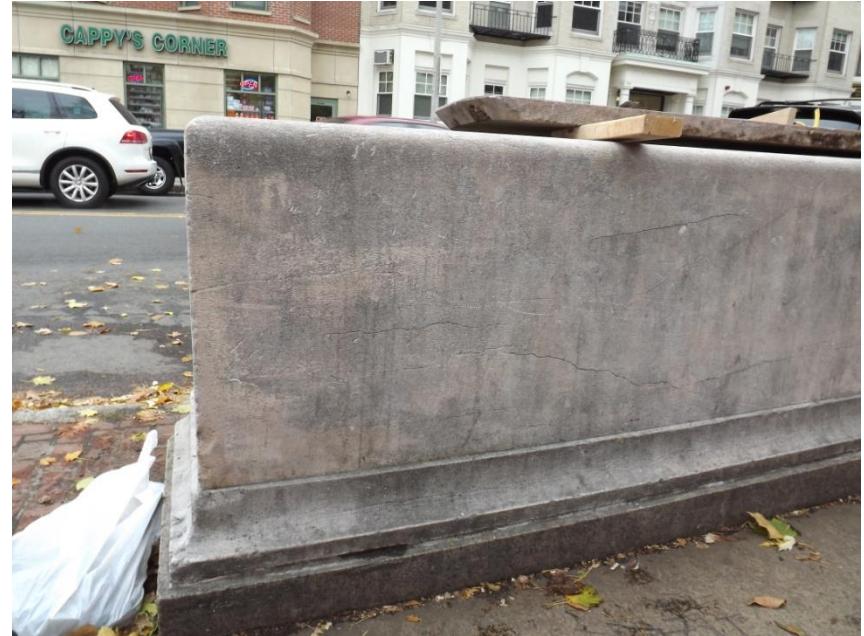
**Horizontal crack in troughs are the result of stresses inherent in the stone.**

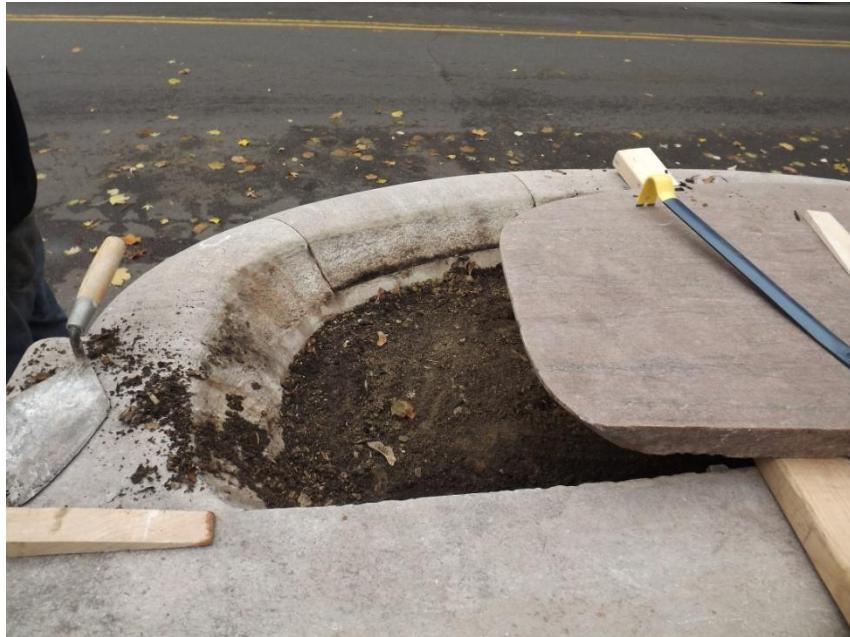
- After the removal of the lid on the south trough it was apparent that the cracks that were observed on the east edge are the seams of a prior "dutchman" repair that is now failing.

**View of interior of south trough with dutchman repair.**

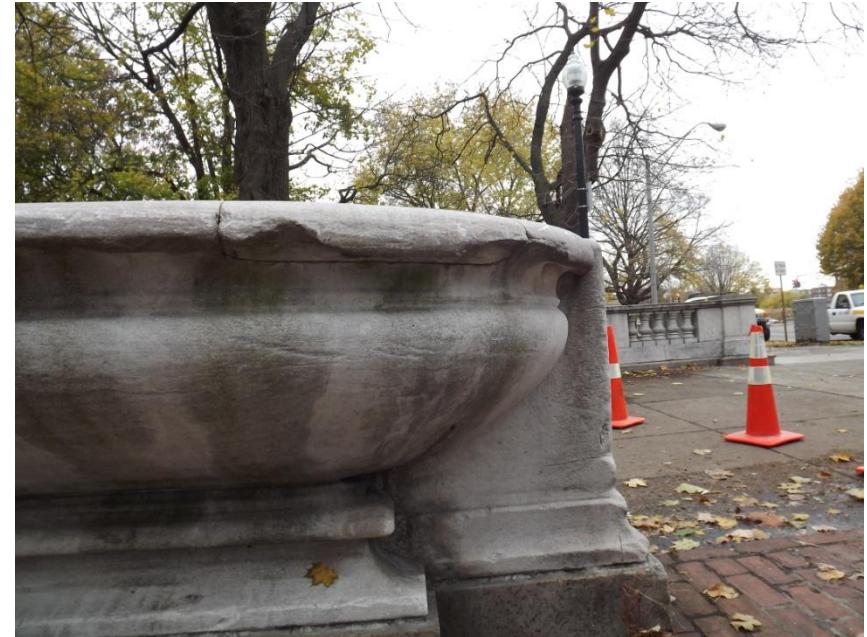
**Exterior view of the same dutchman repair which is now damaged from impact.**

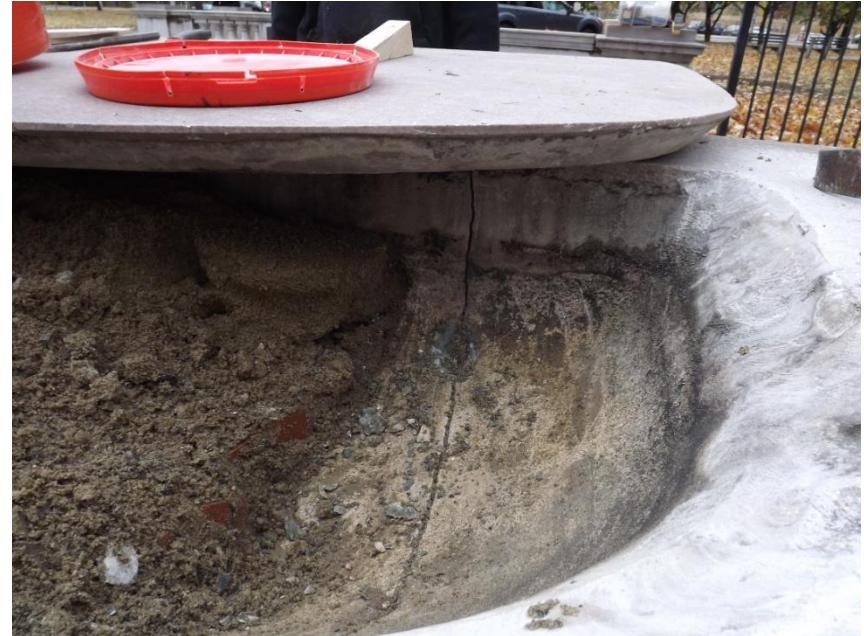
Interior view of north trough with sand scraped away to reveal crack.

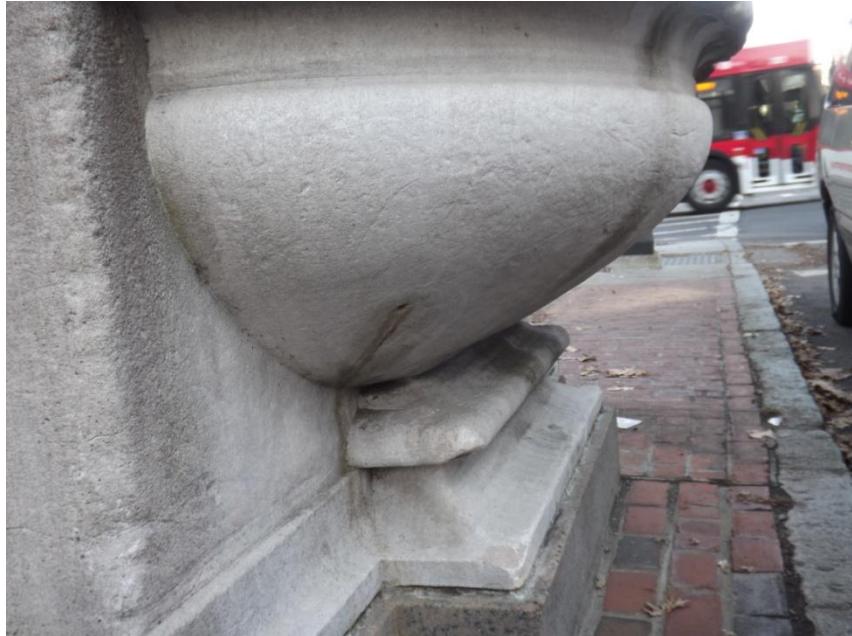
Both troughs originally had holes for drainage. The south trough holes are still draining water but the north trough holes are clogged.

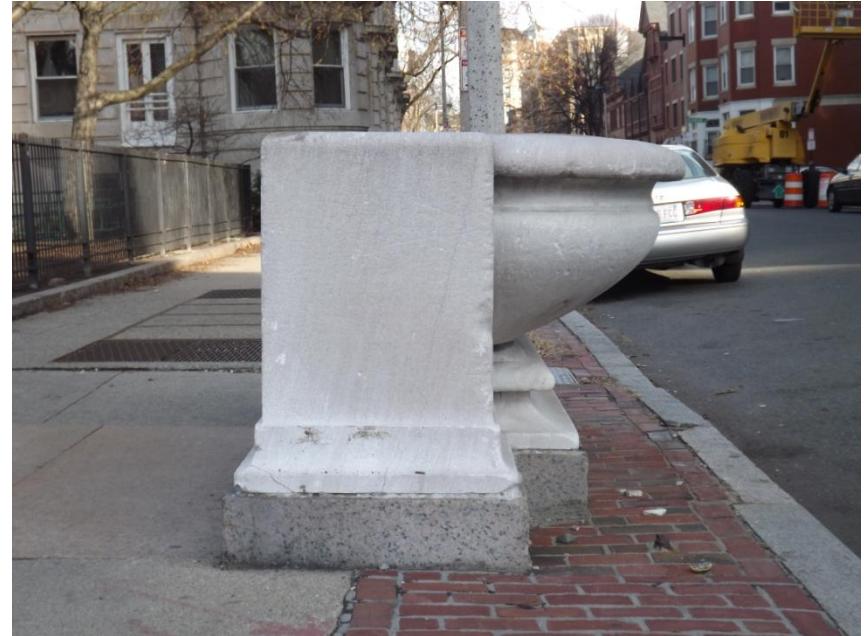
- The north trough is leaning to the east fairly dramatically. The cause of the tilt appears to be related to the settling of the foundation, which in turn may be related to the utilities well that was constructed adjacent to the north end of the trough. There is a possibility that the construction of the utilities well contributed to the cracking of the north trough. The south trough which has an identical stone lid and is filled with sand does not have any structural cracks.

The north trough leans dramatically to the east. The cause of the shift could not be determined but it might be related to sidewalk/road repair or the utility well on the north side.

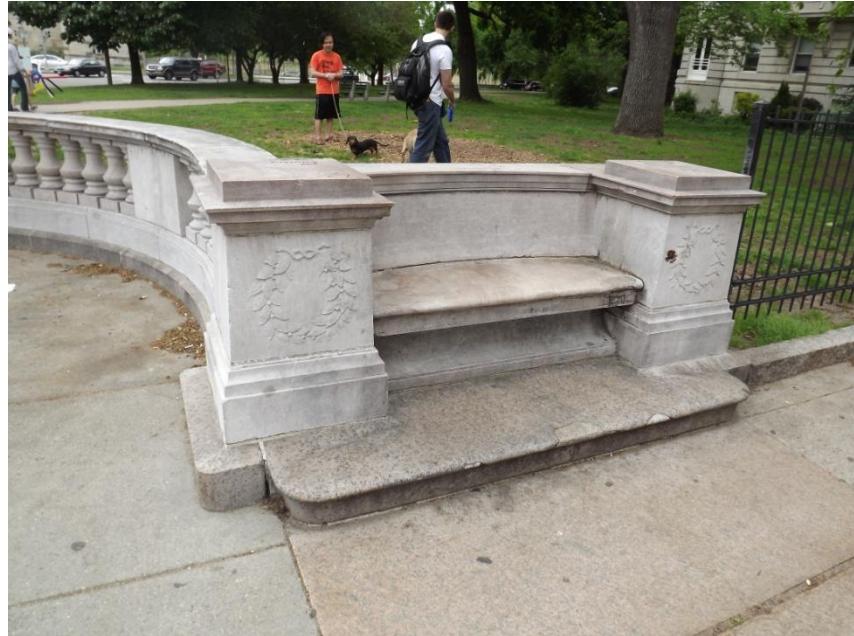
**The north and south balustrades are in good condition overall but have not received any maintenance in several decades.**

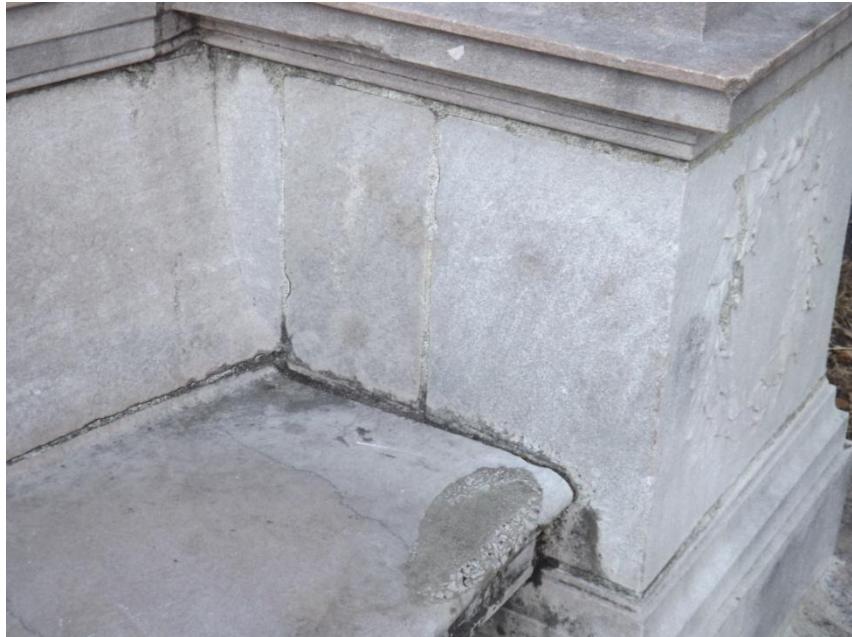
An old patch that is failing is visible at the edge of the bench. The mortar joints are open there is a small amount of displacement of the units.

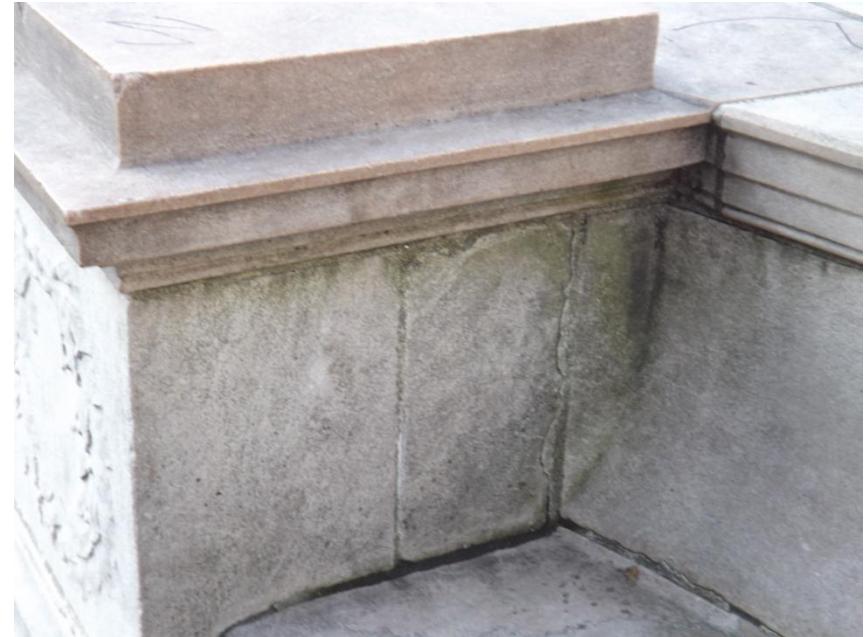
The benches have a film of biological growths and other types of stains. The edges of the stone units are spalled at the mortar joints because some of the previous mortars were too hard.

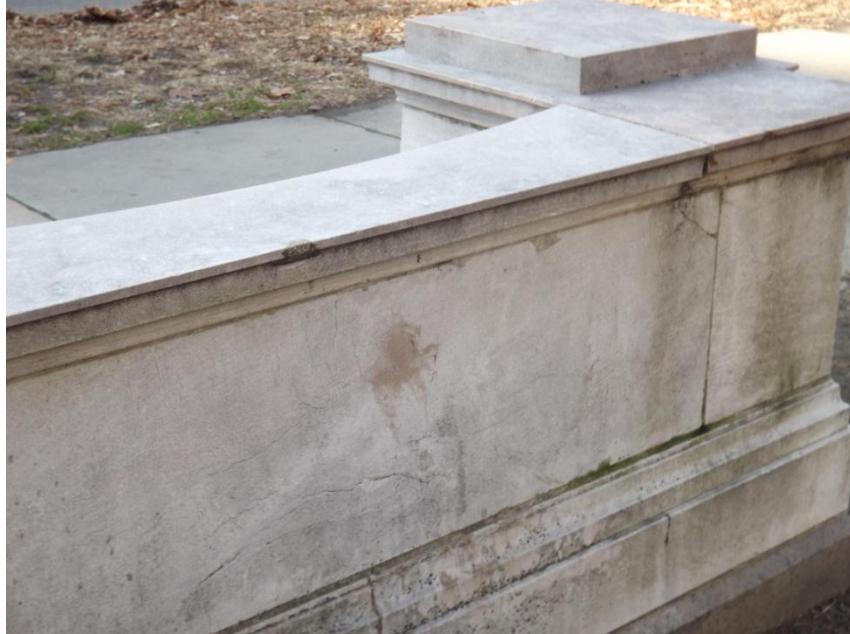
There are numerous small losses at the edges of the units, some of which have been patched in the past with Portland Cement mortar.

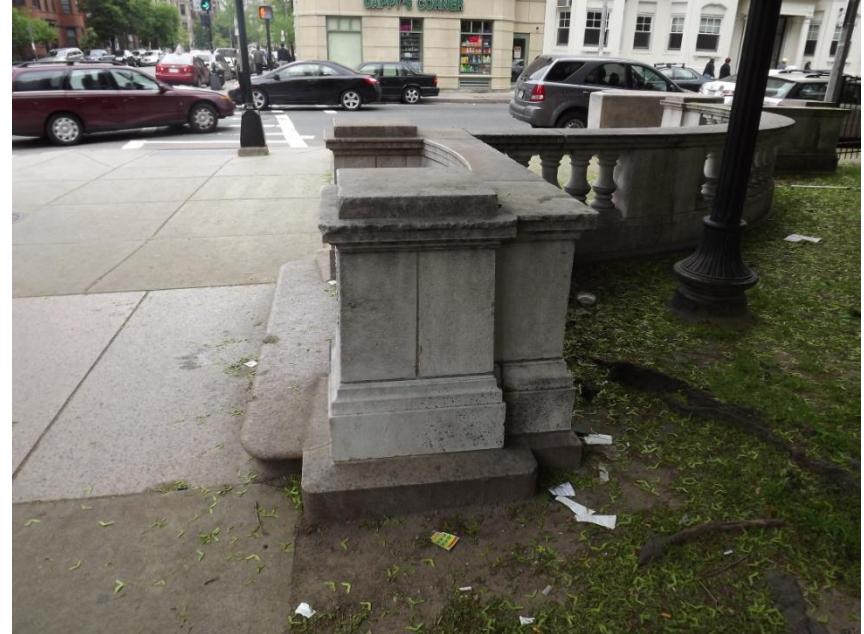
As is the case with the granite bases at the piers, the granite at the benches is spalled from impact by equipment or vehicles.
